Upper Myakka Lake Weir Restoration Feasibility Study

Myakka River Management Coordinating Council Public Meeting,
September 18, 2020

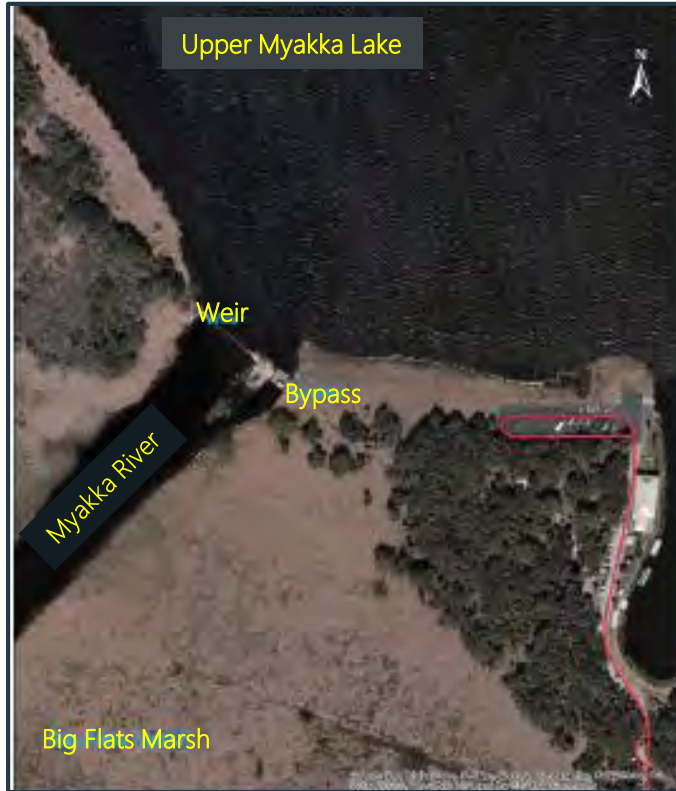
Project Site

- Low-water control structure located at lake outlet
- Constructed to hold water back during the dry season

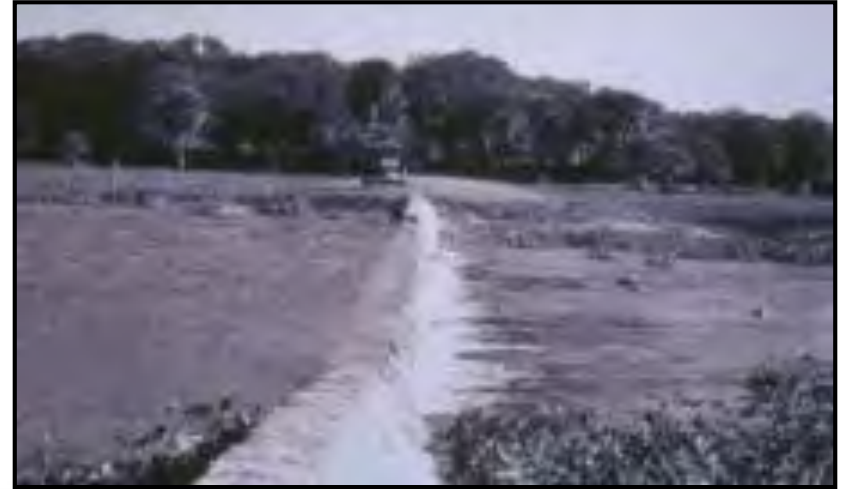
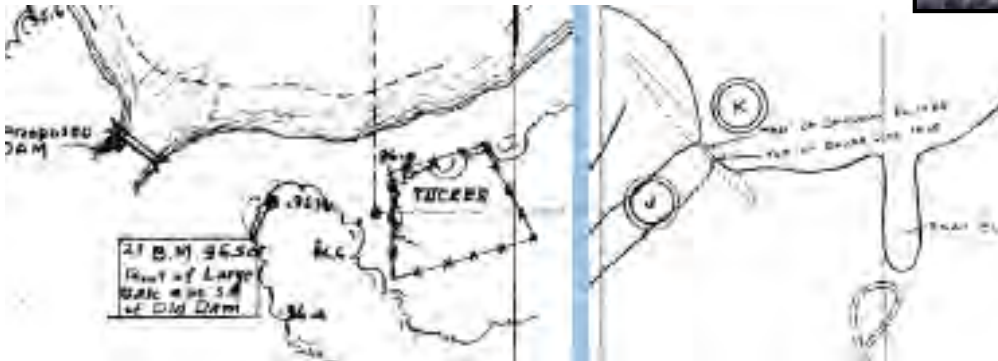
Weir

- 1937 plans show proposed hydrologic modifications
- Constructed in 1938/39
- Lack of drawdown caused unintended consequences

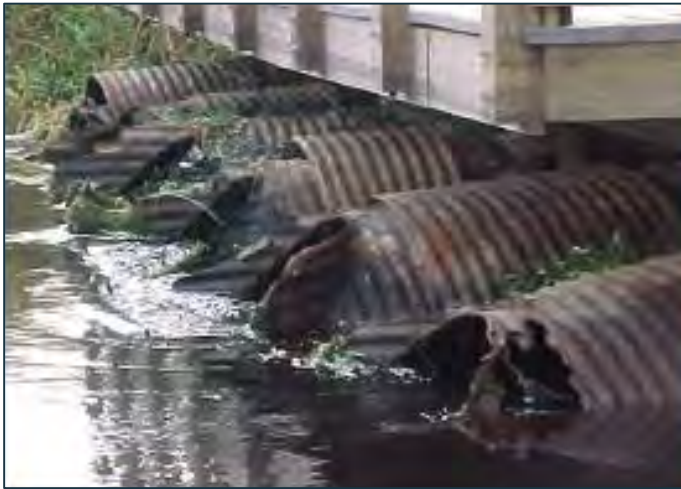
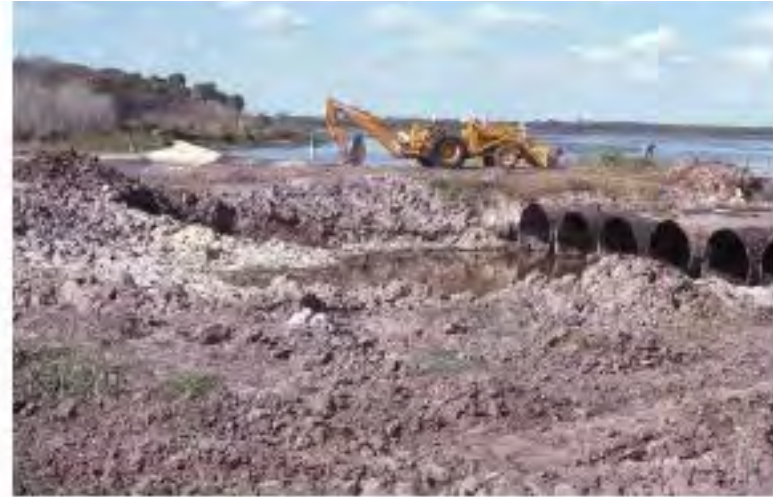
Bypass

- 1974 bypass built to improve negative effects of the weir
- Only marginally successful

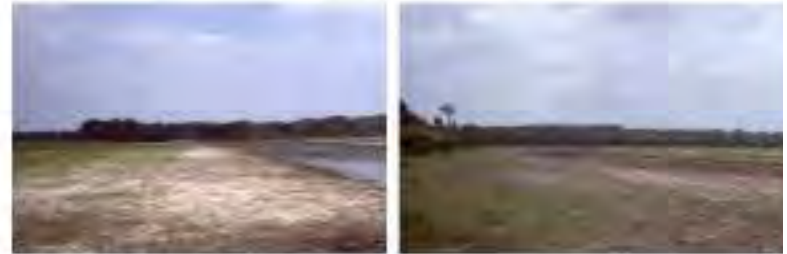
Late 1970s drawdown after bypass construction, with pumping

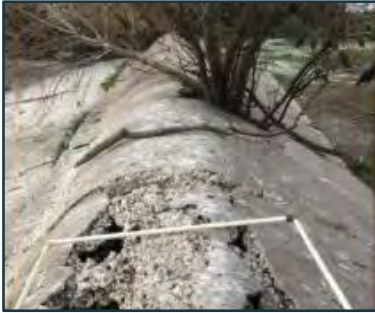
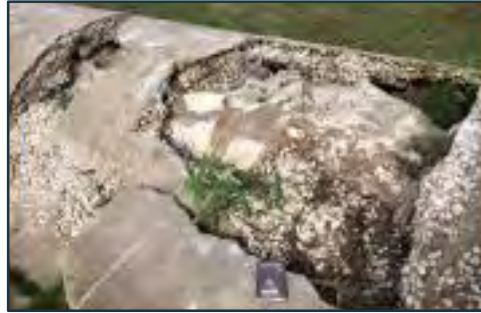
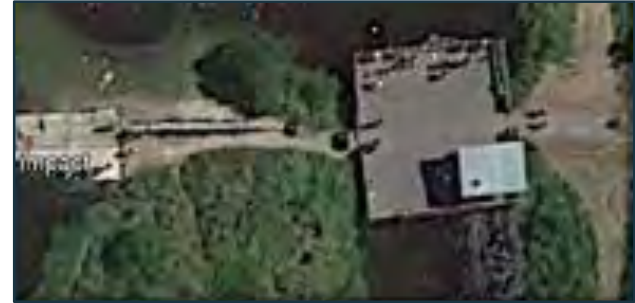
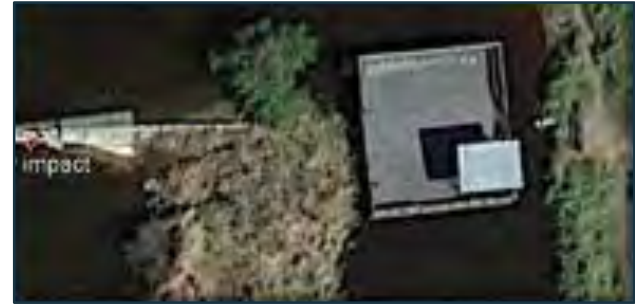
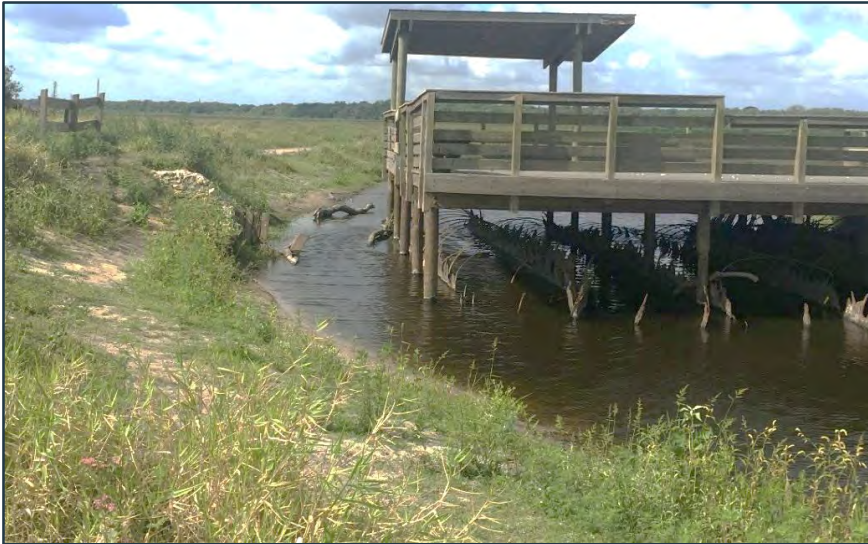
Current Conditions

- Weir degraded
- Rusted culverts
- May 2016 “blow-out”

- Bypass would continue to erode
 - Loss of park property
 - Increased sedimentation downstream
- Structure will continue to degrade and reduce intended function
- Rusted culverts and dilapidating dam present unsafe condition to humans and wildlife
- Unusable viewing deck
- Addressing issues here is part of MRSP's Unit Management Plan

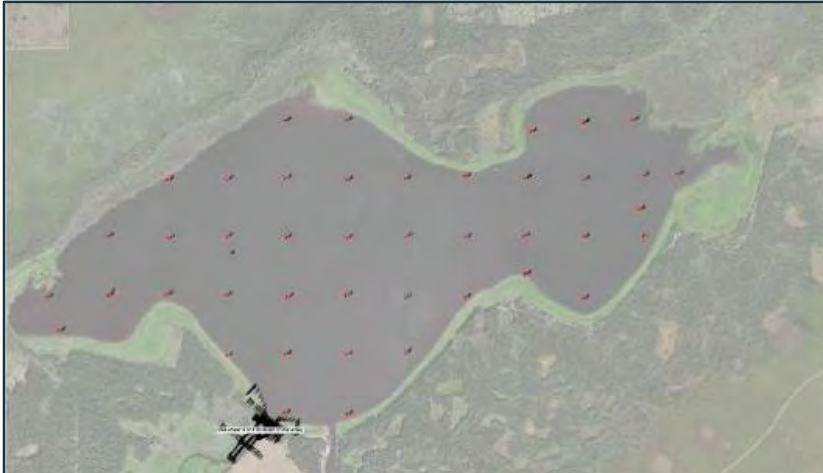
Survey

- Lake/river survey
 - Bathymetry
 - Sediment thickness
 - Profile and cross sections
- Bridges

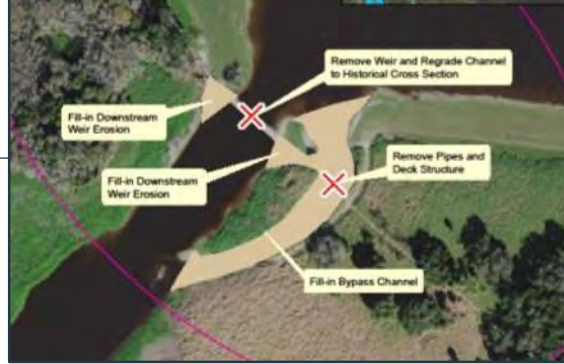
Alt. 1 - Removal

- Three alternatives:
 - Alt 1: Removing the low water control structure and re-wilding the UML outfall
 - Alt 2: Amending the low water control structure to lower the weir invert by 2 ft to elevation 10.41 ft NAVD88
 - Alt 3: Rebuilding the low water control structure to its historical state prior to the recent failures, including the bypass and pipes

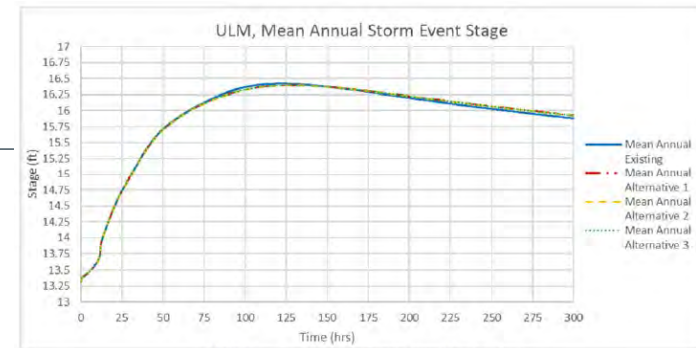
- Objective: to assess flooding impacts
- Myakka River Watershed Initiative (MRWI) model
- Used ICPR4 Software to model
 - 2.33-year (mean annual) 24-hour
 - 25-year 24 hour
 - 100-year 24 hour
- No adverse impacts for any of the three alternatives

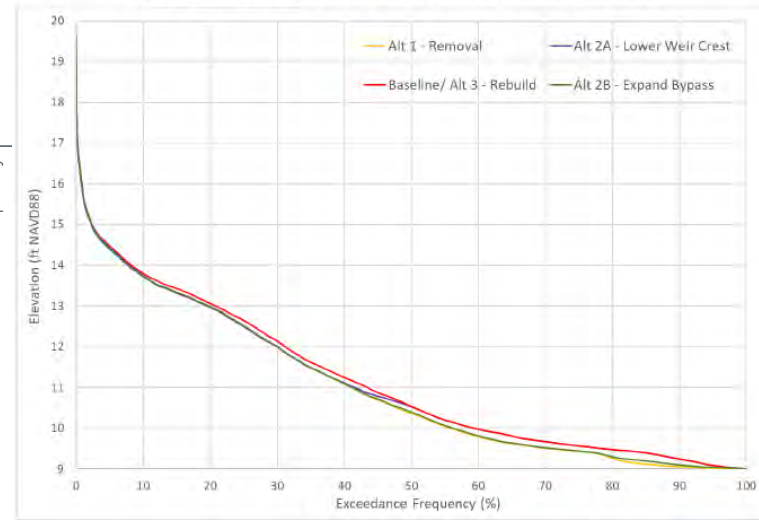
Water Level Exceedance Frequency

- Objective: to further assess restoration and management benefits between alternatives
- Used MIKE SHE integrated surface and groundwater model to simulate 16 years
- Alt. 1 removal showed greatest benefits:
 - Seasonal low water level in UML would reduce by 0.3 ft from the baseline condition
 - ~70 acres of additional land would be exposed during seasonal low water level conditions

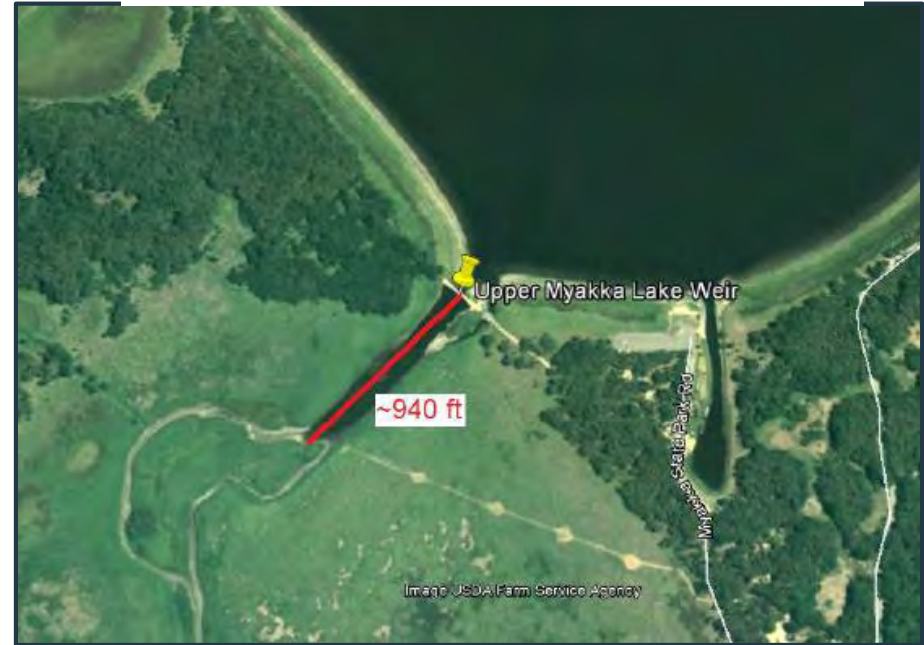
- Lake will not drain if remove weir
- Downstream controlling shoal crest at 9.4 ft NAVD
- Acts as natural control structure for the lake (typical in-line lake transition for Florida)
- Controlling shoal crest seldom right at lake boundary – typically formed and sustained some distance downstream

Downstream Controlling Shoal Crest Exposed During Dry Season
(Image Source: Google Earth, 4/2006)
